FACT SHEET – ~~INTERNAL ONLY~~

Environmental Stewardship Initiatives for
VF300 Fence Construction along the Southwest Border
U.S. Border Patrol Yuma Sector
August 2011

U.S. Customs and
Border Protection

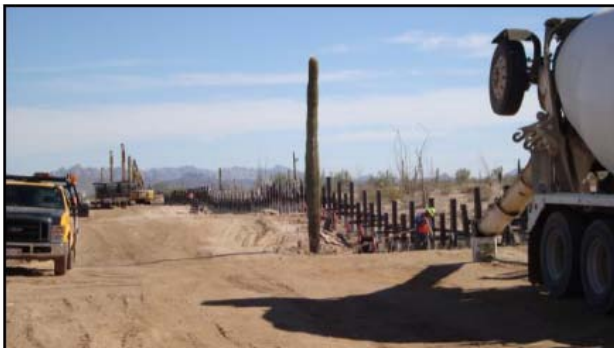
**Construction Efforts Avoid a Saguaro Cactus
Section CV-2**

Environmental monitors also assisted construction contractors to reduce impacts on saguaro cacti, which is a forage species for the endangered lesser long-nosed bat. The locations of saguaro cacti were recorded and efforts were made to minimize their destruction. Transplantable cacti were removed from the project area and replanted elsewhere. Of

the 276 saguaro cacti identified in Sections CV-2 and CV-2A, only 17 were impacted and 3 of these cacti were transplanted outside of the project area.

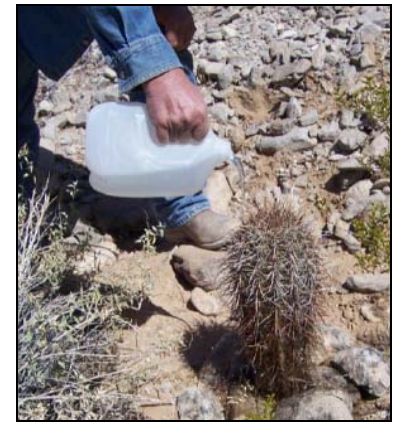
Section CV-2A

Environmental Monitor Waters Transplanted Saguaro Cactus
